**DEPARTMENT OF CIVIL ENGINEERING**

**MEGHNAD SAHA INSTITUTE OF TECHNOLOGY**

**A Semi-annual insight into the Civil Engineering World**

# CIVIL O NEWS

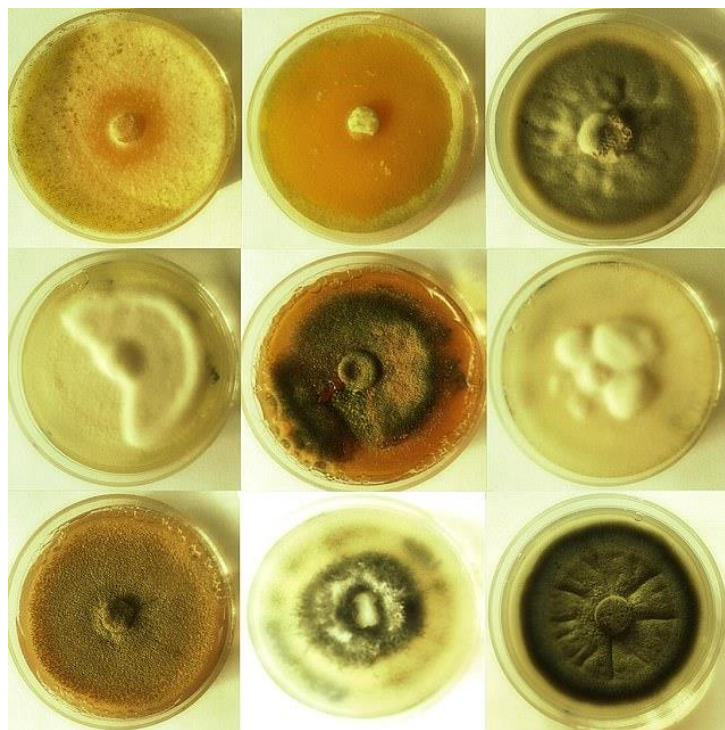
Researchers screened a number of fungi looking for a candidate that could help fill concrete cracks. Congrui Jin, CC BY-ND

We initially screened about 20 different species of fungi in order to find one that could withstand the harsh conditions in concrete. Some we isolated from the roots of plants that grew in nutrient-poor soils, including from the New Jersey Pine Barrens and the Canadian Rocky Mountains in Alberta.

We found that as calcium hydroxide from concrete dissolved in water, the pH of our fungal growth medium increased from a close-to-neutral original value of 6.5 all the way to a very alkaline 13.0. Of all the fungi we tested, only *T. reesei* could survive this environment. Despite the drastic pH increase, its spores germinated into threadlike hyphal mycelium and grew equally well with or without concrete.

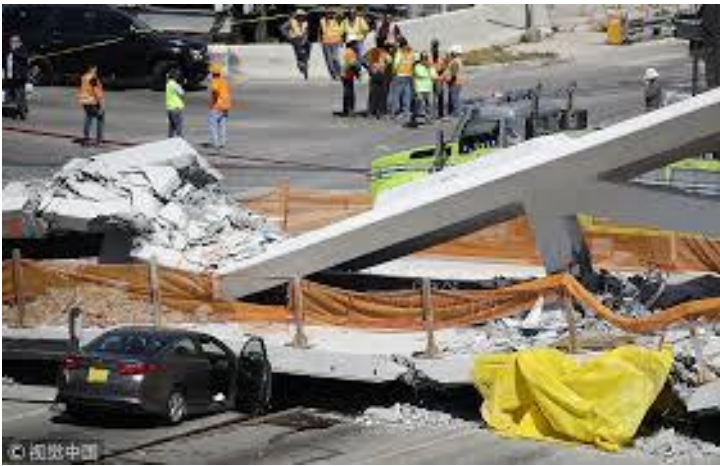
Every element holds clues to what happened – including the cracks in the concrete and stress marks in the metal rods. AP Photo/Wilfredo Lee

In Miami at the moment, forensic engineers and technicians from the National Transportation Safety Board are on the scene. Right now they're collecting samples of materials from the bridge to test for their physical properties. They're reviewing drawings and plans, and examining both industry standards and site engineers' calculations to understand what was supposed to be built – to compare with what was actually constructed. They'll look at photographs and videos of the collapse to identify the sequence of events and locations of key problems. Of course, they'll also talk to witnesses to find out what workers and passersby saw and heard around the time of its collapse.

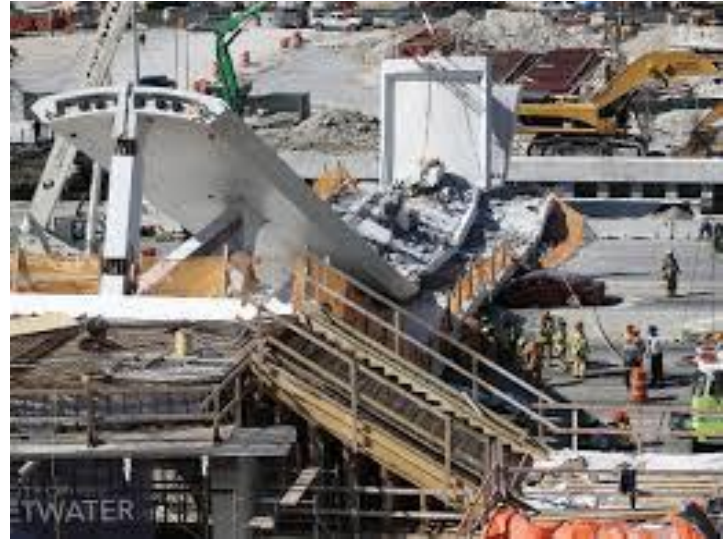
An artist's rendering of what the final bridge was supposed to look like. City of Sweetwater

Two key elements of the bridge design, the tall center pylon and pipe supports, were not yet in place when the structure collapsed. They hadn't been scheduled to be added until later in the process – and the bridge wasn't slated to open until next year, so it's likely that the
